# LAVA CAVES IN SUBURBAN AUCKLAND NEW ZEALAND.

## Lava Caves in Suburban Auckland.

### Abstract

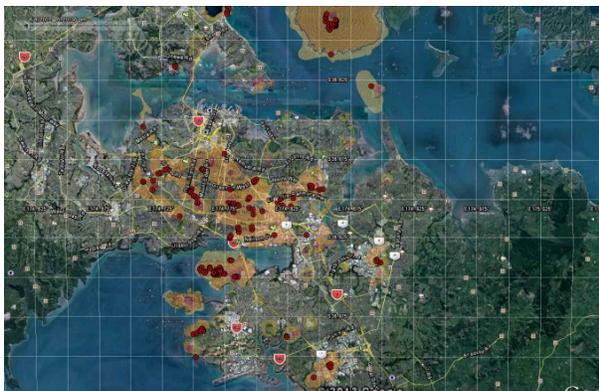
Fig. 3. Location of lava caves. (Red dots).

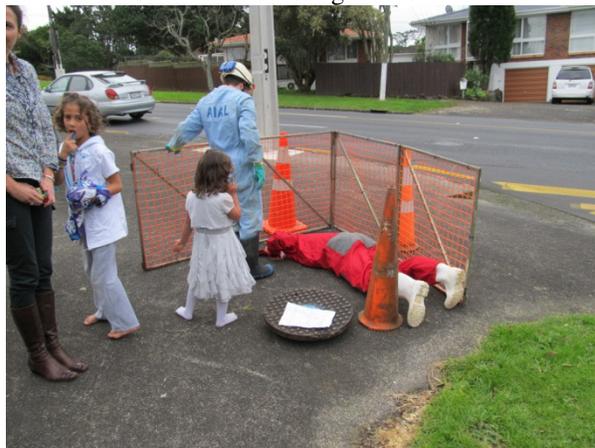
Fig.7. A manhole entrance into a cave complex under the road.

But others have had manholes put in to protect them, either in the street or in school grounds.

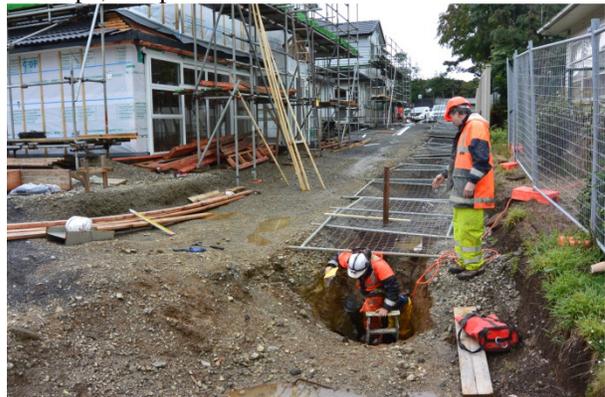
Fig. 10. The cave is at the near end of the trench. The developer was stopped from filling in the trench which hampered deliveries to the building sites. The cave extends to left and right of the picture.

One a private developer doing infill housing, found a cave in a trench and let the council know. I was rung up as no one was willing to enter and I am known for being able to explore and survey. So I did a survey both with tape, compass and camera.

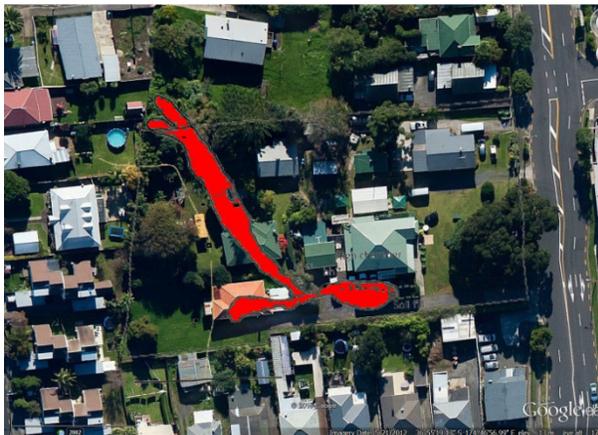
Fig. 12. The extent of the cave under the building site and surrounding houses.

The cave in fact was quite extensive going under three properties and one of the proposed houses. The council was horrified at the thought of hoses collapsing and them being sued for wrong permits. So the owner was stung for getting all sort of engineers reports and

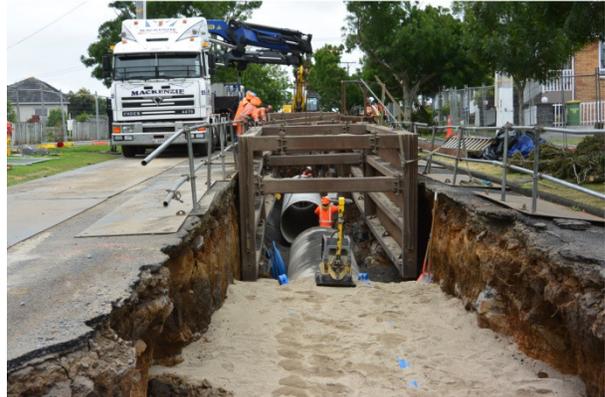
Fig. 13. The large pipe trench traversing lava cave country.

The other , In December 2015 was part of a big 35km water pipe line extension construction, a multi million dollar project. It was known that it was likely to cut into caves and GPR, percussion and boreholes were done in advance and then an exploratory dig. A cave was found. The council was told. Iwi came and blessed it. The archaeologist walked by. Nobody could go in. It was a construction site. I was called in. I was allowed to go in briefly after inductions for the site with all PPEs (hard hat, boots, long trousers long sleeves, gas meter and signing off. A very quick survey on the back of a hand was enough to determine it was worth keeping. To do the proper survey, which also included a 3d laser survey, we had to spend a morning getting more inductions, drug tested, and two days to get a ‘confined spaces certificate’. At the site we were signed in, the cave was gas tested , we also wore gas meters and we

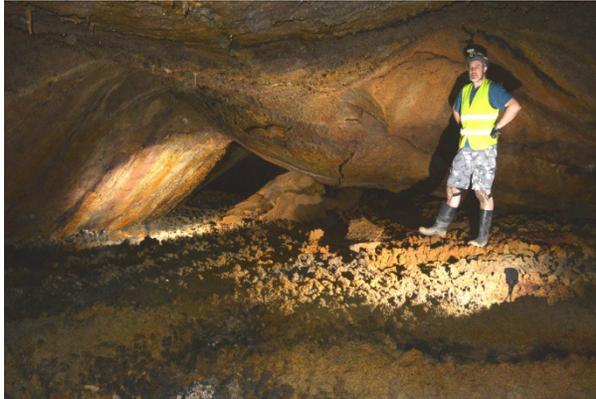
Fig. 16. A worthwhile cave but needs a engineers design to span it with a water pipe.

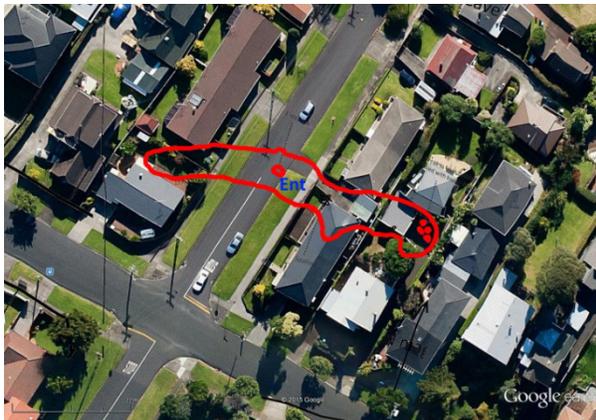
Fig. 18. The mapped extent of the cave. The water pipe will go up the right hand side of the road. There was a break in at the right hand lobe of the cave that had not been reported.

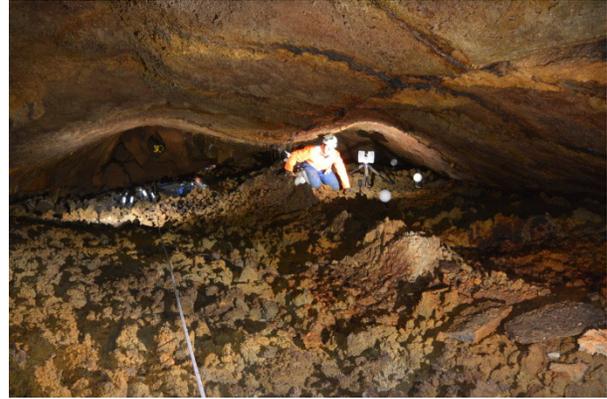
Fig. 19. The old and the new. On the left is the compass and tape survey. On the right is a \$50,000 3D laser scanner. The white spheres are the control points.
